## **Roan Head Boom Buoy Vessel**

### **Project Report**

**March 2015**

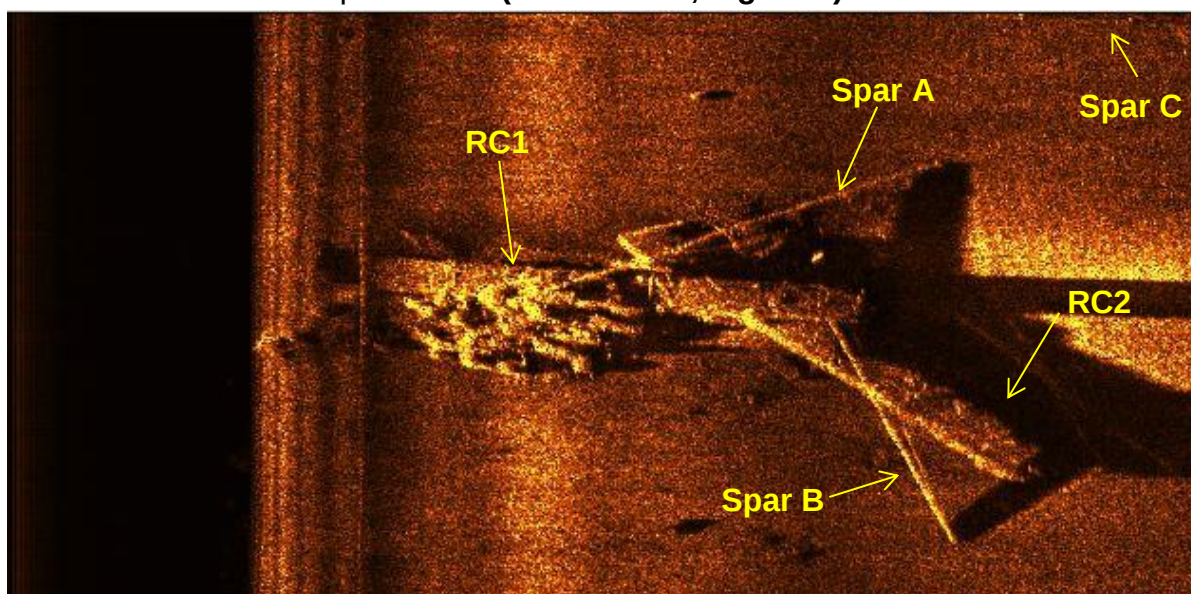
PLATE 1: SIDE SCAN SONAR IMAGE OF THE TARGET SITE (RC1 AND RC2)

The first rectangular contact (RC1) is 30m long by 3m wide, oriented north to south. There is a large pile of boom nets and buoys abutting the northern end of the remains to the west of the contact. This feature overlays a second rectangular contact of the same dimensions (RC2). RC2 is oriented northeast to southwest with RC1 overlaying the northeastern end.

Both contacts lie under two spars (Spar A and Spar B respectively). Spar A is approximately 22.6m is oriented northwest to southeast; while Spar B is approximately 24.9 and is oriented east-northeast to west-southwest. Subsequent assessment of the survey data following the diver surveys indicates the presence of a third spar (Spar C) approximately 5m to the east of the main target site. This is visible as three strong returns, which mark the position of flanges visible on the spars underwater (**Plate 3**). Spar C is at least 16m long, however the contact extends beyond the range of the side scan runs.

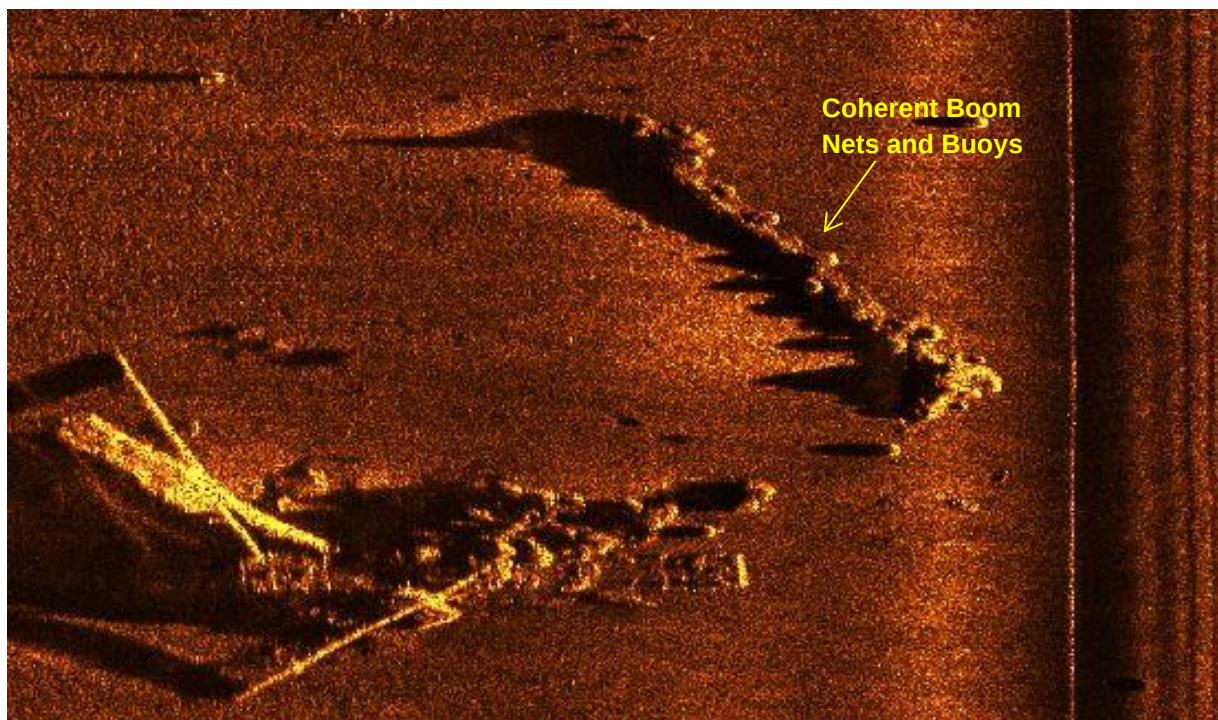
PLATE 2: SIDE SCAN SONAR IMAGE OF ASSOCIATED BOOM DEFENCE DEBRIS

There is a coherent pile of boom net and buoys (30m long by 2m wide and standing between 1m and 2m proud of the seabed) approximately 13m to the northwest of the target site, oriented northeast to southwest.

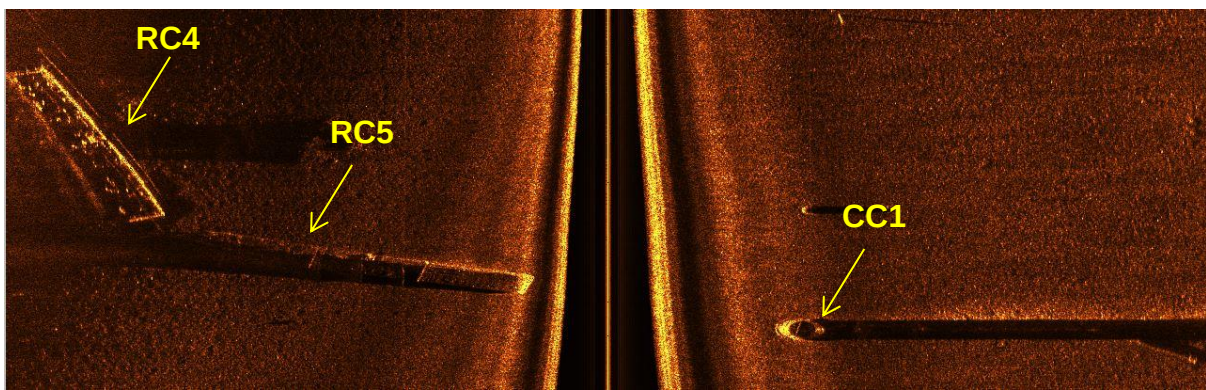
PLATE 5: SIDE SCAN SONAR IMAGE OF RC4, RC5 AND CC1.

Rectangular Contacts 4 and 5 (RC4 and RC5) are located to the west of the target site in a depth of approximately 5m. RC4 measures 30m long by 3m wide and the remains stand approximately 1.2m proud of the seabed. The shadow from the image indicates a single high point in the centre of the contact (approximately 2.4m high). The feature is likely to be slightly higher as the shadow extends beyond the side of the survey record. Similar to RC3 there are a number of strong returns on the main contact suggesting the top of the feature is populated with smaller features (**Plate 5**). RC4 is oriented northeast to southwest.

RC5 is situated approximately 4m to the north of RC4, and has the same dimensions. Unlike RC3 and RC4, there is no high point in the shadows. There are two strong linear returns approximate 10m from either end of the contact (**Plate 5**). RC 5 is oriented north to south. CC1 is situated approximately 6m to the north of the remains of RC5.

It is recommended that the RC3, RC4, RC5 and the circular feature (CC1) observed in proximity to RC4 and RC5 should be the subject of further investigation to confirm the identity of the remains, to document their condition and to map their configuration. Evidence from historic photographs suggest that the winches on the

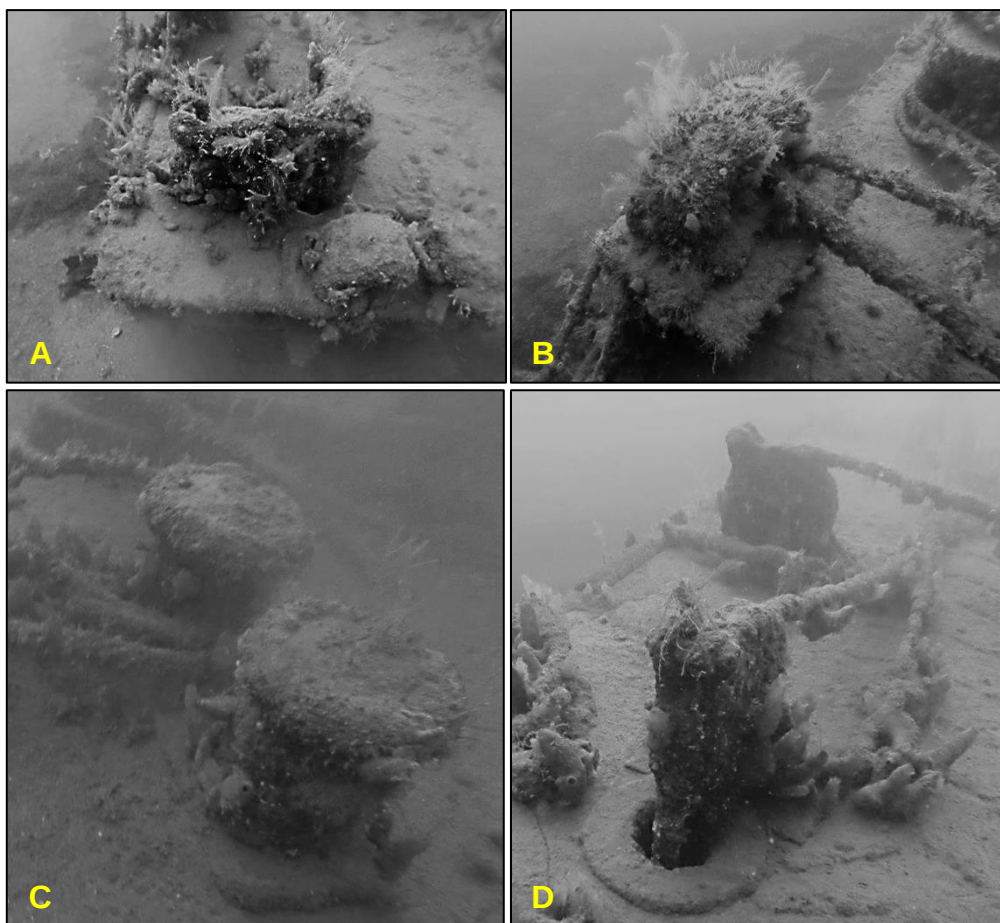
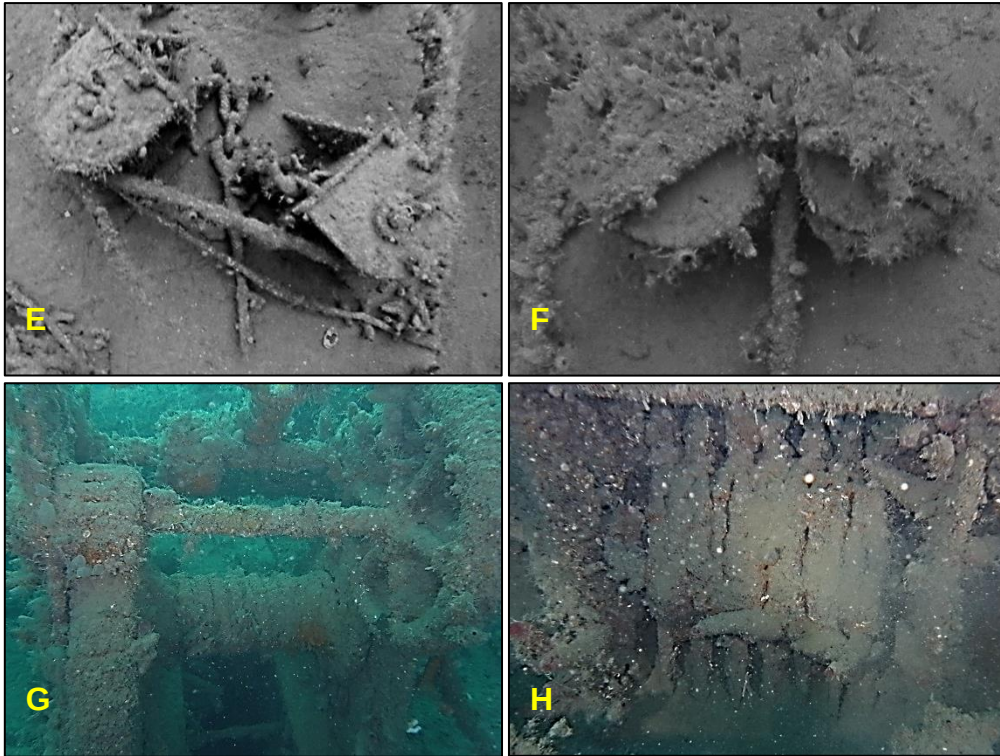
Upon descent divers encountered the wrecks of two long, narrow vessels. RC1 was upright, and the 'deck' was divided into three 10m sections. The sections at each end were populated with a number of pulleys (running both along and across the vessel), posts (with wire guides), cleats, fairleads, bollards and bitts (**Plate 6A – 6F**).

Each of the pulleys was associated with a 0.16m diameter aperture, and wires *in situ* in the pulleys passed through tubes to the underside of the vessel. The central section comprises several other pulleys and posts, surrounding a large winch which has the capacity to operate twelve wires (**Plate 6G and 6H**).

**PLATE 6: PHOTOGRAPHS OF VESSEL MACHINERY - A) CLEAT; B) FAIRLEAD; C) BITTS; D) PULLEYS (RUNNING ALONG AND ACROSS THE VESSEL); E) BOLLARDS; F) POSTS WITH WIRE GUIDES; G) PART OF THE WINCH MECHANISM SHOWING CENTRAL MOON-POOL; H) CLOSE UP OF PART OF THE WINCH MECHANISM THAT OPERATE 6 OF THE 12 WIRES.**

The machinery present on the vessel is in good condition with all elements intact. Networks of wires from various points cover the remains. There are two clear walkways with a tread-plate – either side of the centre line of the vessel, with machinery inboard and outboard of these lines (**Plate 7A**). These features are also present on RC2 (**Plate 7B**).

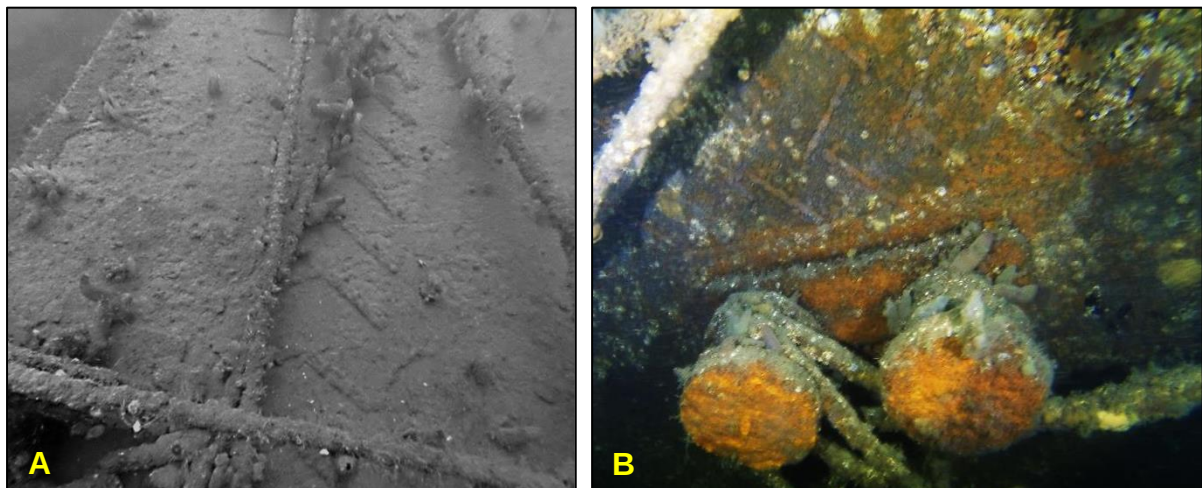
**PLATE 7: PHOTOGRAPHS OF TREAD-PLATE ON A) RC1 AND B) RC2**

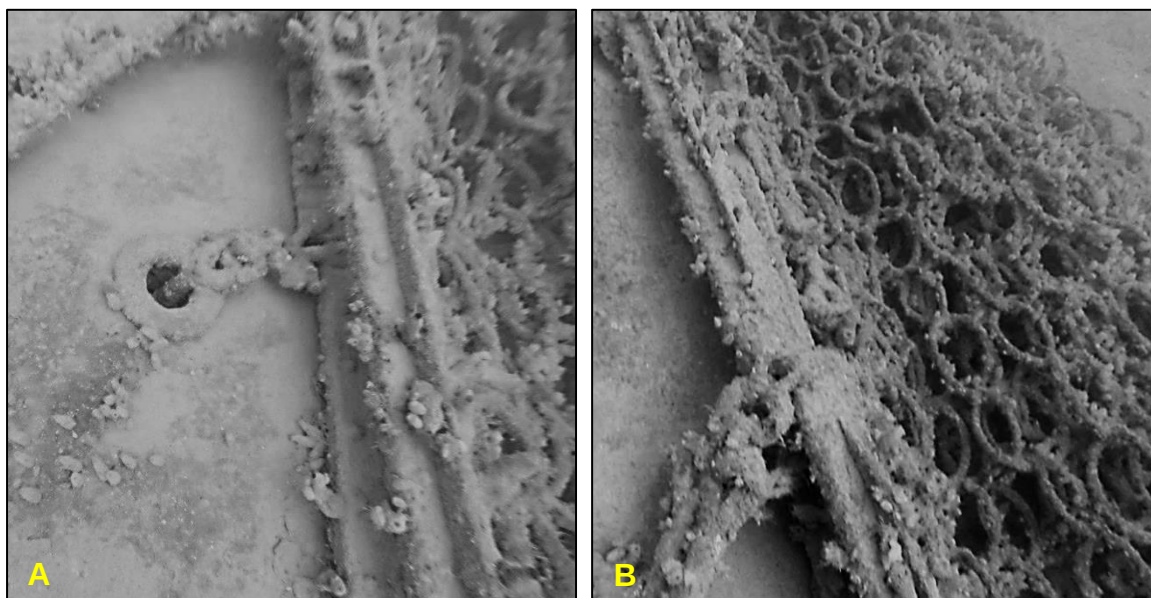
RC1 overlies the remains of RC2. RC2 appears to have been the same type of vessel as RC1, however the wreck has capsized. The joins between the three sections like those observed on RC1 are clearly visible and there are a number of correlating apertures on the underside of the vessel. Several wires protrude from these apertures. These are attached to steel beams onto which linear piles of boom netting are secured (**Plate 9**). This boom netting lies off to the southeast side of RC2.

PLATE 9: RC2 BOOM NETTING: A) SHOWING WIRES CONNECTING TO STEEL BEAMS FROM UNDERSIDE OF RC2; B) BOOM NET ATTACHED TO THE STEEL BEAMS

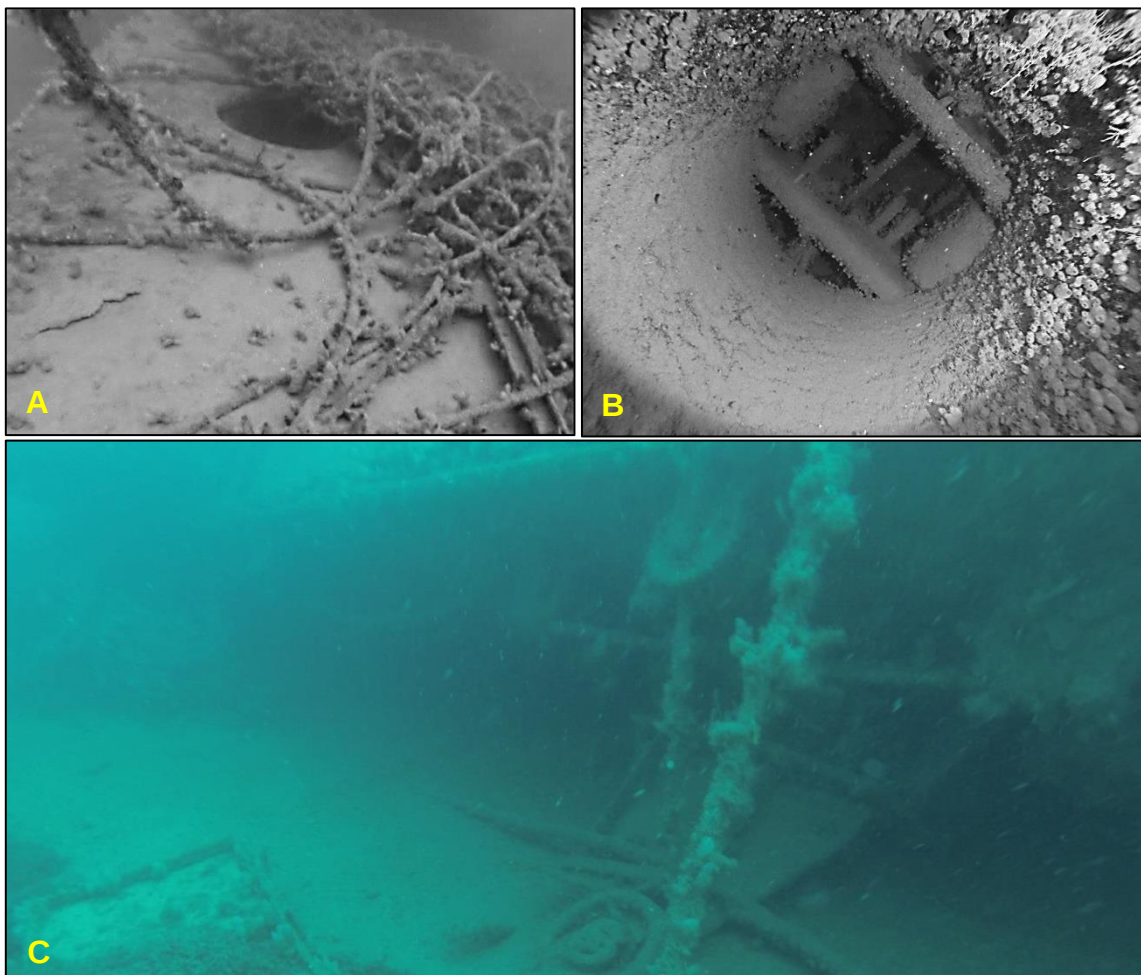
In the centre of the middle section there is a large circular aperture (known as a moon-pool, which is a hole in a vessel that provides access to the water). This was directly over the remains of a crushed winch (**Plate 10**) – supporting the above interpretation that the two vessels are likely to be identical.

**PLATE 10: RC2 WINCH AND MOON-POOL: A) MOON-POOL ON UNDERSIDE OF RC2; B) VIEW INTO MOON-POOL SHOWING PART OF THE WINCH; C) REMAINS OF INVERTED CRUSHED WINCH ON THE 'DECK' OF RC2**

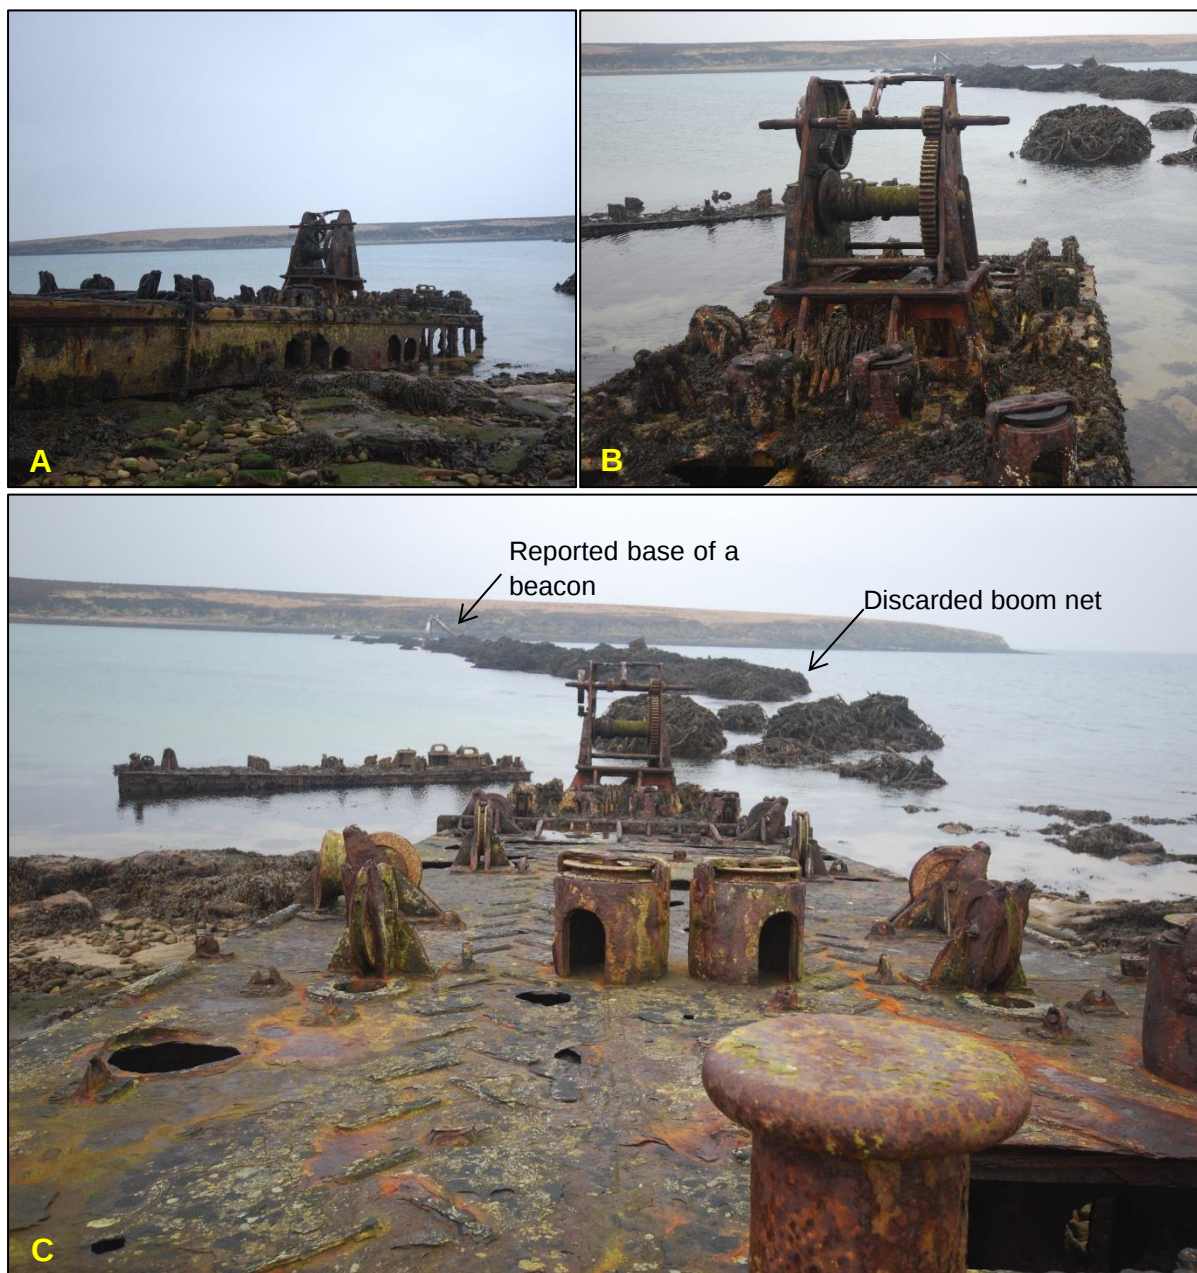
PLATE 16: REMAINS OF A PONTOON ON ROAN HEAD, FLOTTA

The first is the largely intact remains of a pontoon on the beach on Flotta, referenced in the Canmore record for the remains of anti-submarine boom defences (Canmore ID 249683) as “...a flat metal structure extends into the intertidal zone on the Flotta side of Calf Sound. It is 1m wide and at least 5m long. The remnants of winding gear are attached to the seaward end”. Images of this pontoon are shown in **Plate 16**.

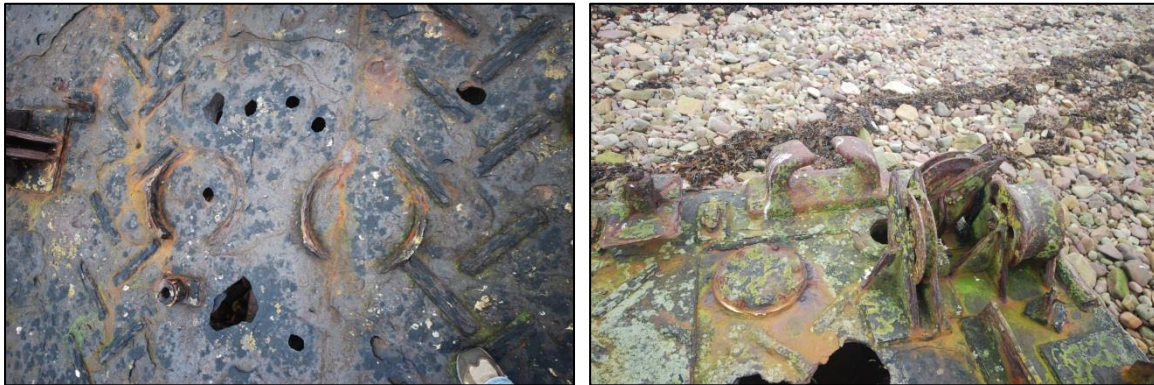
Two sections of the pontoon currently rest in the inter-tidal zone to the west of a large pile of discarded boom netting and the reported remains of a 20<sup>th</sup>-century beacon (**Plate 16C**), although it should be noted that there are no charted beacons in the area. It is possible that this is the remains of an anchor for one of the Hoxa booms. The third section has broken away and is resting perpendicular to the midsection in the water. There is evidence to suggest that some salvage has taken place, particularly on the remains of the larger section, as some of the fittings have been removed or partly removed and there is evidence of sections of burning (**Plate 17**).

**PLATE 17: EVIDENCE OF BURNING INDICATING SALVAGE OF MACHINERY**

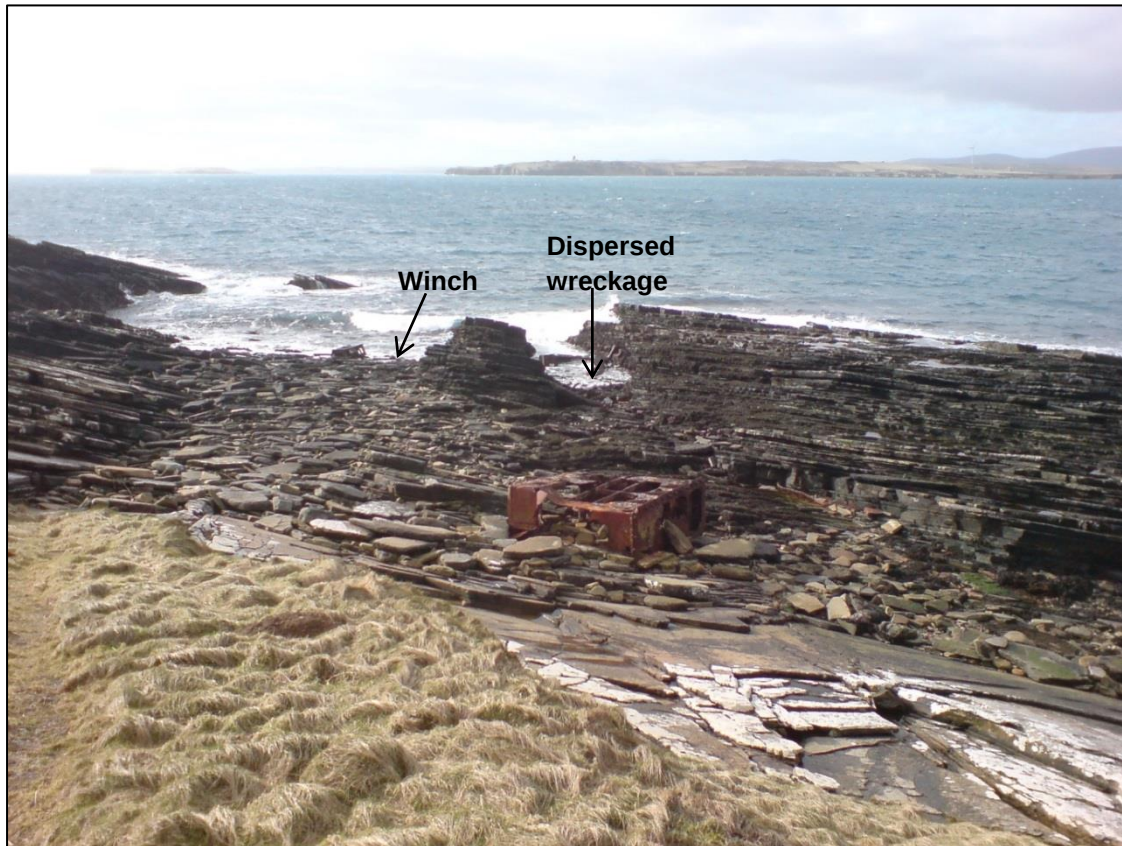
**PLATE 19: DISTRIBUTION OF PONTOON WRECKAGE AT HOXA**

The more dispersed remains of a second pontoon can be found on the rocks beneath Hoxa battery. The debris is described in the Canmore site record for Leynei Geo (Canmore ID 314006) as “fragments of a large metal structure, possibly part of a ship or boom, are wedged fast between the rocks” (**Plate 19**).

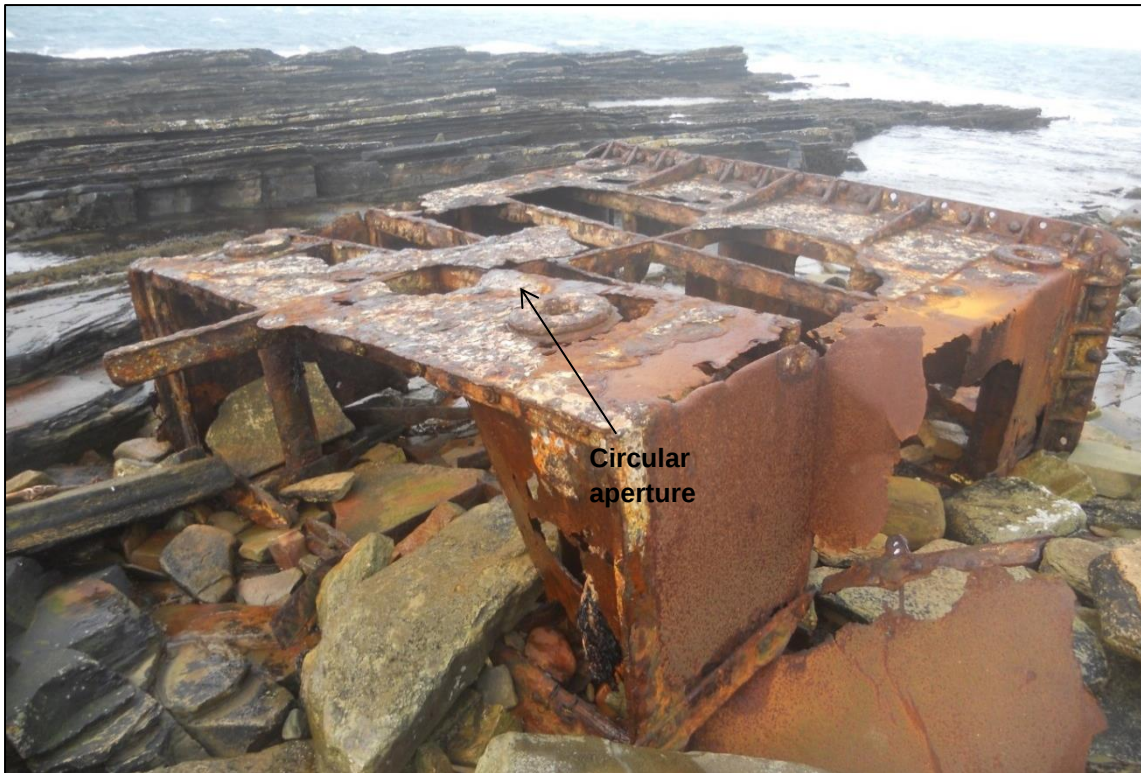
PLATE 20: MORE INTACT PORTION OF PONTOON SECTION AT HOXA

This site includes the remains of at least one section of a pontoon (broken and present in two portions). One large portion measuring 3.13m long by 3m wide with a height of 1.2m is half way up the beach. Four circular apertures and associated tubes can be seen (**Plate 20**).

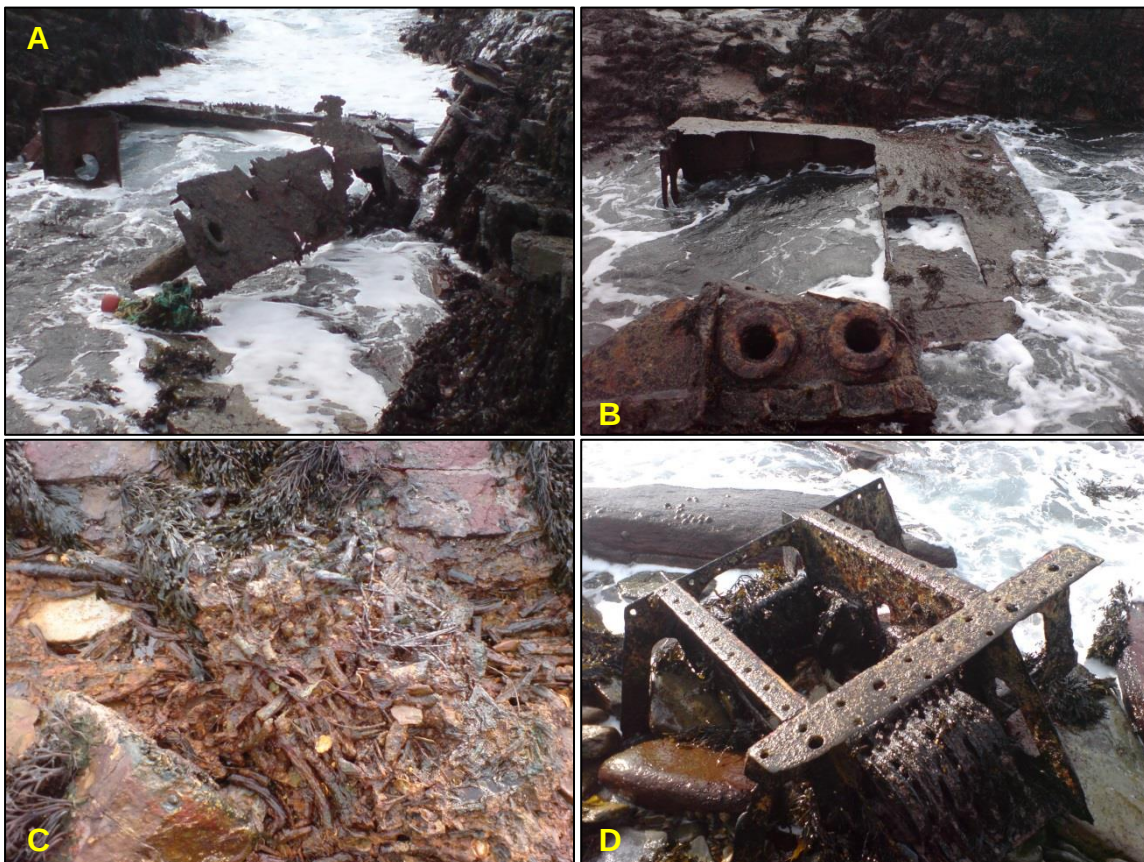
A second more fragmentary portion, wedged between rocks closer to the low water mark is 3.18m long, but is too broken up to gauge other dimensions (**Plate 21A and 21B**). This is associated with several corroded piles of wire (**Plate 21C**). Although the machinery and fittings from the pontoon are no longer *in situ*, likely a result of the high energy environment they rest in, a winch with the same configuration of those observed on Flotta and on the target wreck sites was observed close to the low water mark in the vicinity of the rest of the wreckage (**Plate 21D**).

PLATE 21: DISPERSED PONTOON DEBRIS AT HOXA: A AND B) FRAGMENTARY REMAINS OF A PORTION OF PONTOON SECTION; C) CORRODED NET/WIRES; D) WINCH MECHANISM
