## **Roan Head Boom Buoy Vessel**

### **Project Report**

**March 2015**

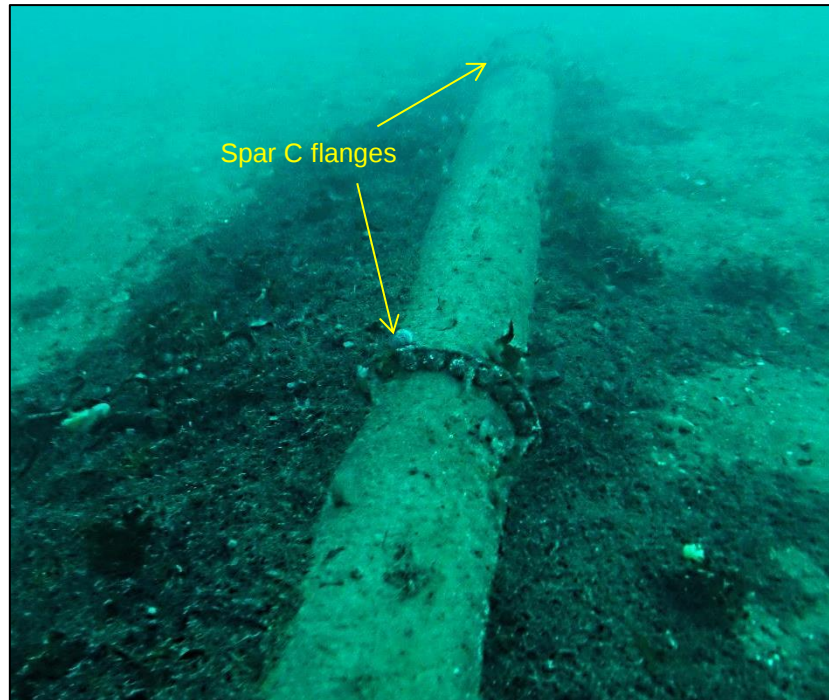
**PLATE 3: PHOTOGRAPH OF SPAR C**

Both contacts lie under two spars (Spar A and Spar B respectively). Spar A is approximately 22.6m is oriented northwest to southeast; while Spar B is approximately 24.9 and is oriented east-northeast to west-southwest. Subsequent assessment of the survey data following the diver surveys indicates the presence of a third spar (Spar C) approximately 5m to the east of the main target site. This is visible as three strong returns, which mark the position of flanges visible on the spars underwater (**Plate 3**). Spar C is at least 16m long, however the contact extends beyond the range of the side scan runs.

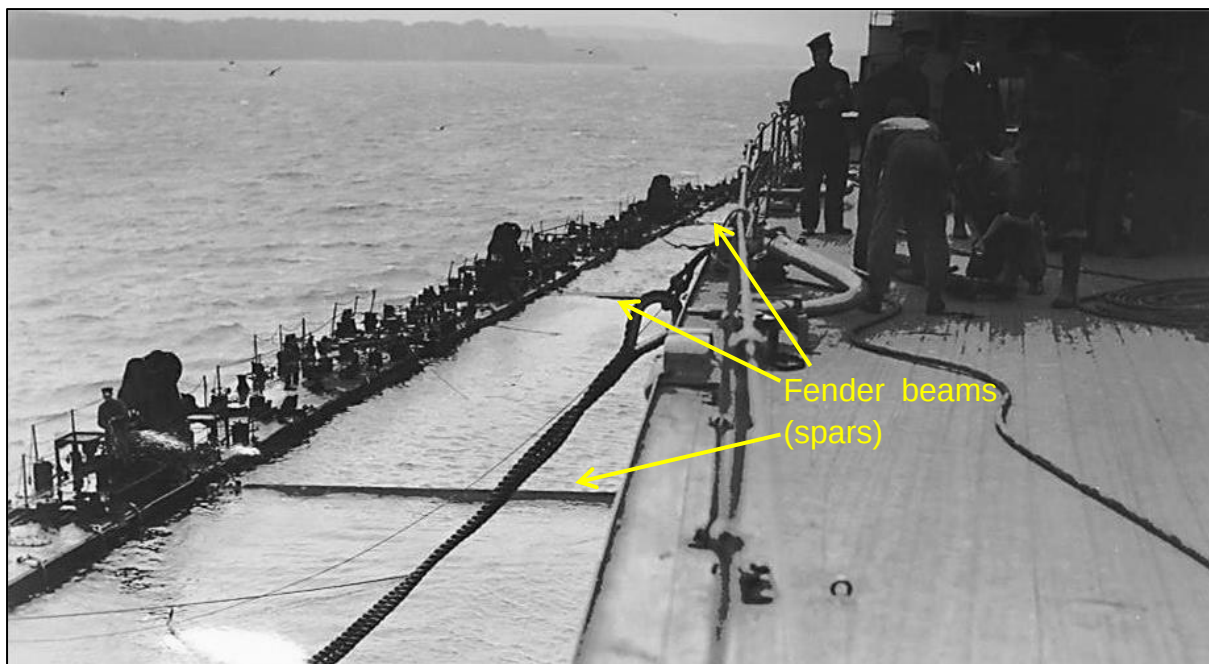
PLATE 11: EXAMPLES OF SPARS USED TO KEEP PONTOONS AWAY FROM THE SHIPS THEY ARE PROTECTING

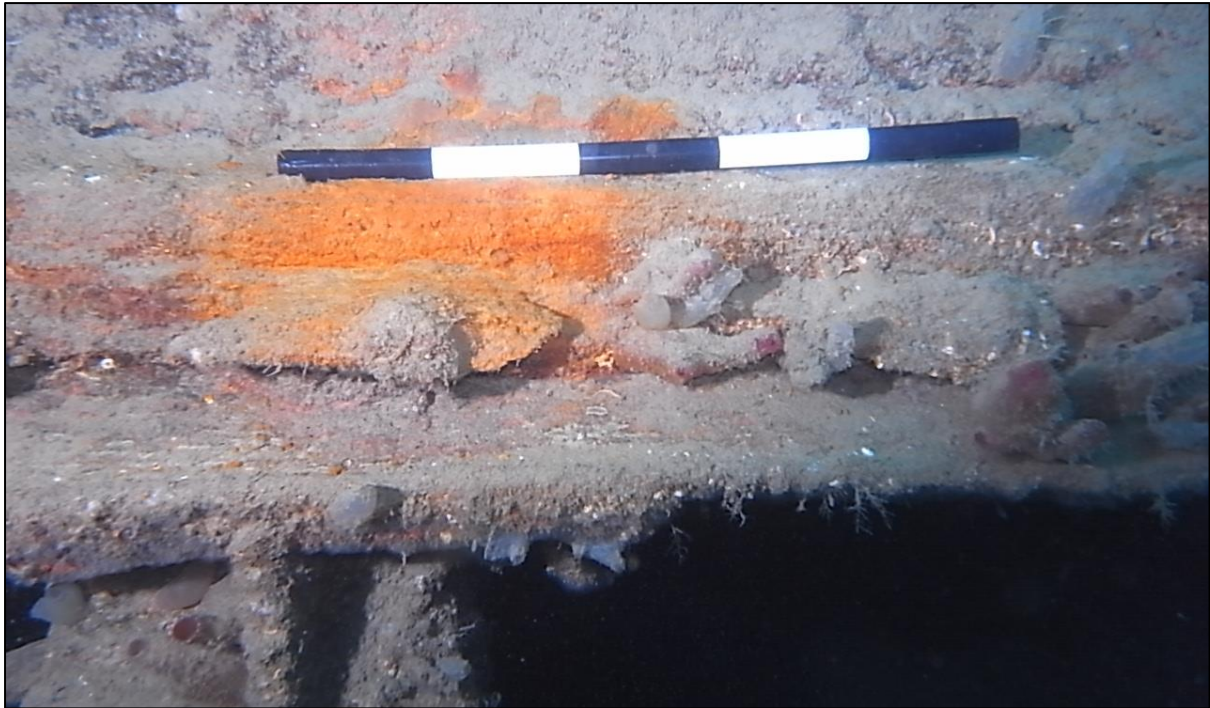
RC1, RC2 and historic records of the ATCPP's indicate that each 90 foot pontoon comprises three 30 foot sections, made of steel. The top edges of the pontoons have a wooden rubbing strip for protection (**Plate 12**).

**PLATE 12: EVIDENCE OF WOODEN RUBBING STRIP**

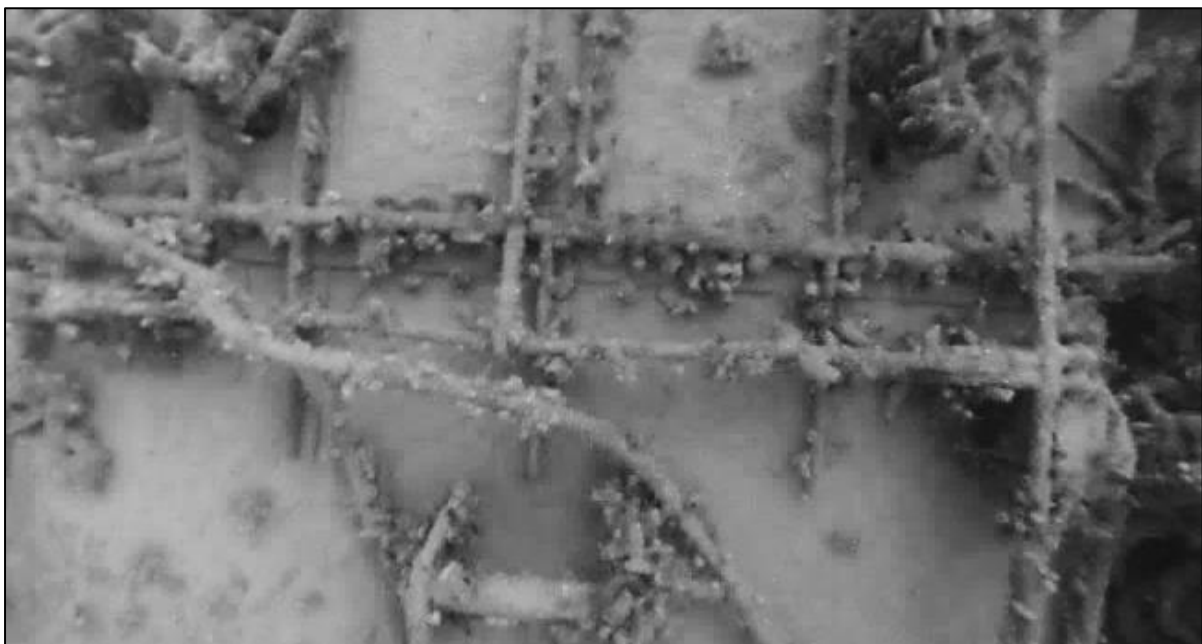
There is an oval access hatch on each section facilitating access to the inside of the pontoon. The sections are bolted together as shown in **Plate 13**.

**PLATE 13: JOIN BETWEEN TWO SECTIONS OF THE PONTOON**

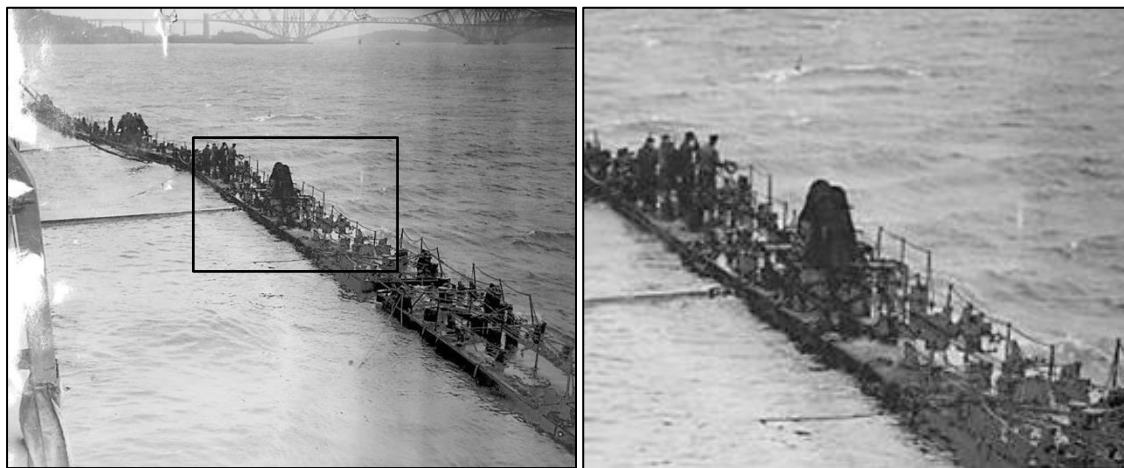
The winches on the pontoons that were recorded during this survey indicate that wire was pulled along the pontoon, whereas similar pontoons in operation at other bases (e.g. Rosyth) show winches to operate at 90 degrees to those at Scapa Flow (**Plate 14**) – pulling wire laterally across the pontoon, rather than along it.

**PLATE 14: ALIGNMENT OF WINCH ON PONTOONS DEPLOYED FROM ROSYTH (ADM244-26).**

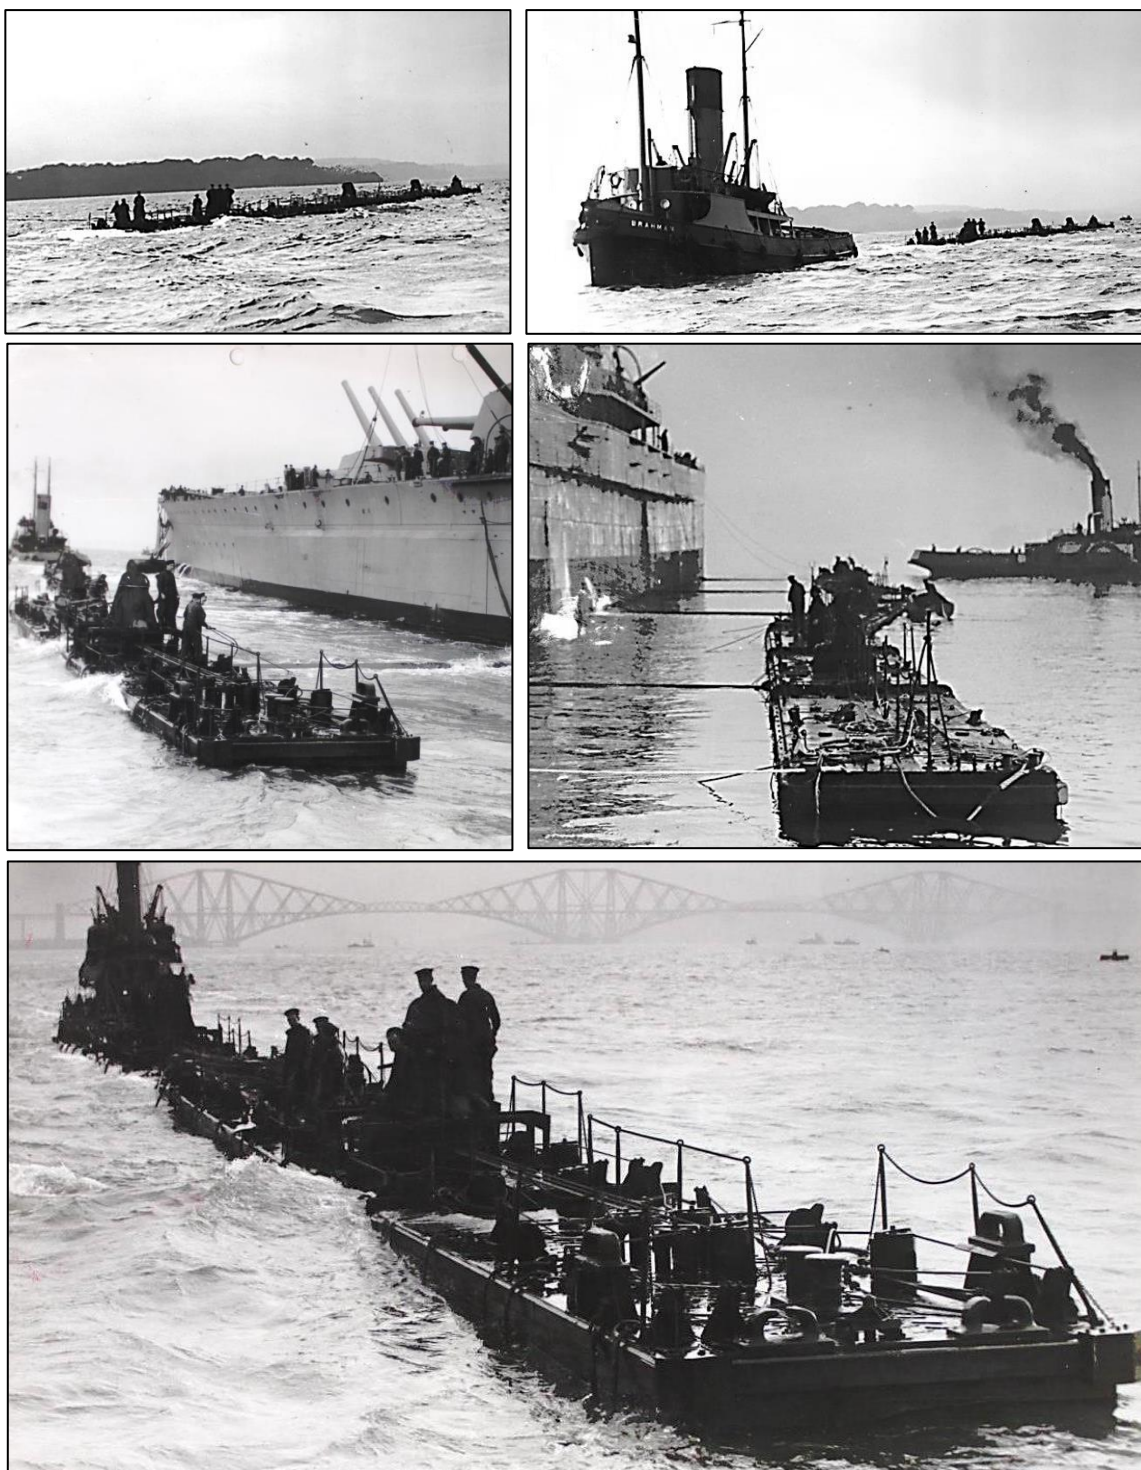
The historic photos of the pontoons in operation protecting the HMS Duke of York in the Firth of Forth clearly show the operational challenges involved with their deployment. Sailors are shown standing on the pontoons, several of which are attached together, whilst they are being towed into position. The images suggest that there would have been some railings around the edges of the pontoons. These are no longer present on the pontoons identified and recorded during these surveys (**Plate 15**).

**PLATE 15: PONTOONS IN OPERATION PROTECTING HMS DUKE OF YORK IN THE FIRTH OF FORTH (ADM 224/26)**

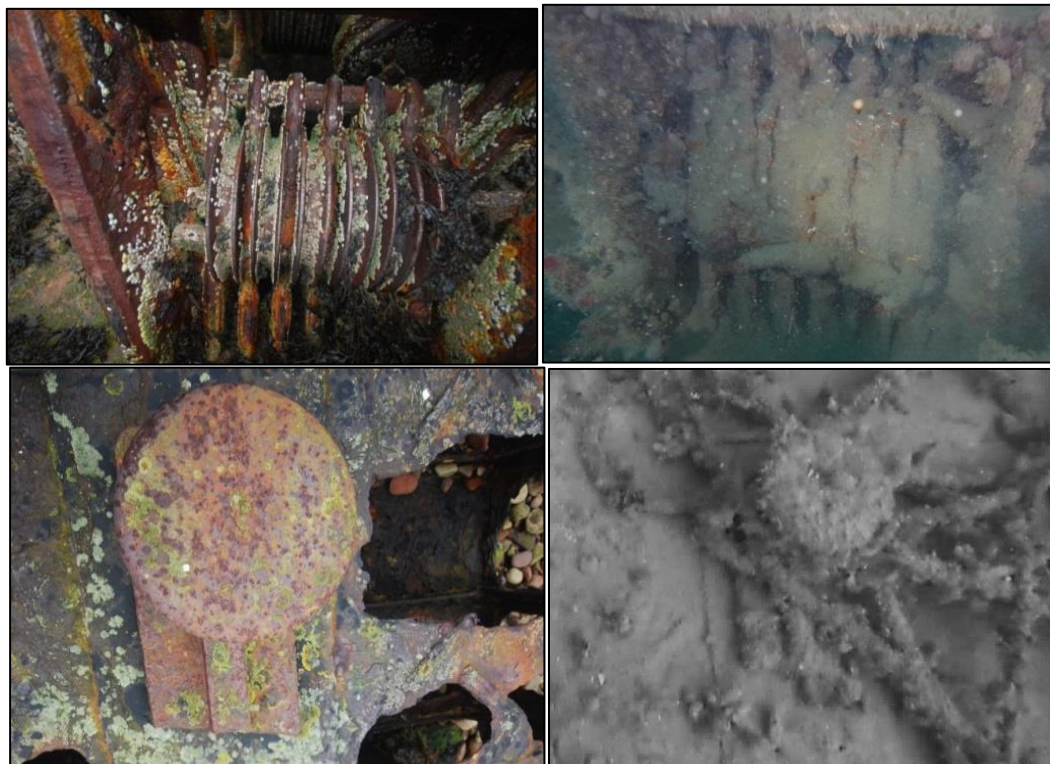
The features on this pontoon replicate exactly those found on the sites underwater. Examples of these can be seen in **Plate 18**.

**PLATE 18: EXAMPLES OF FEATURES ON THE FLOTTA BARGE REPLICATED UNDERWATER**

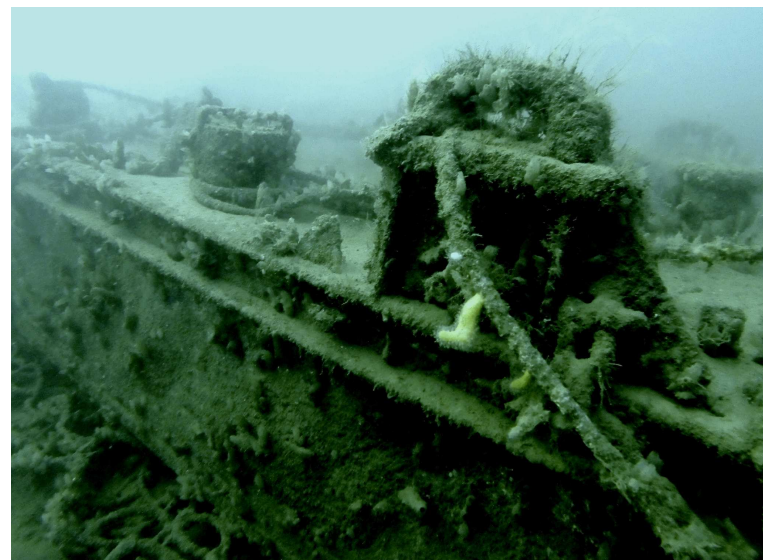
A: Machinery on RC1 showing fairlead, post (with wireguide) and pulley

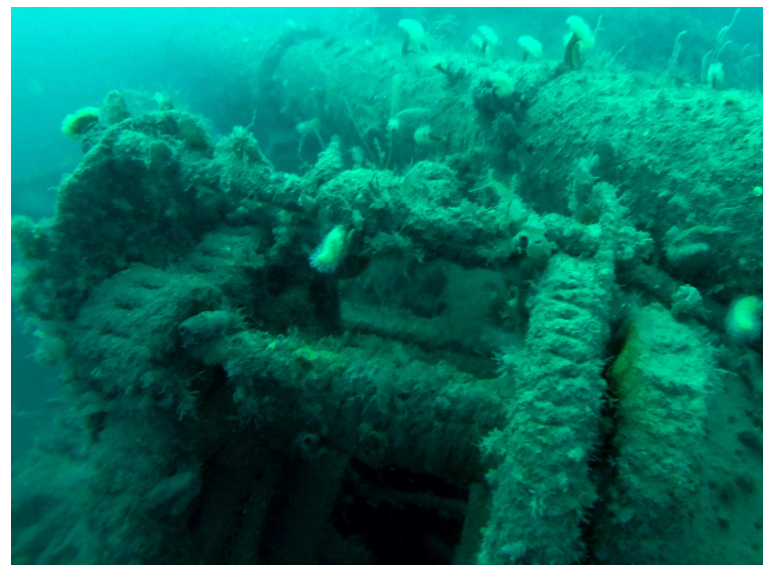
B: Winch on RC1

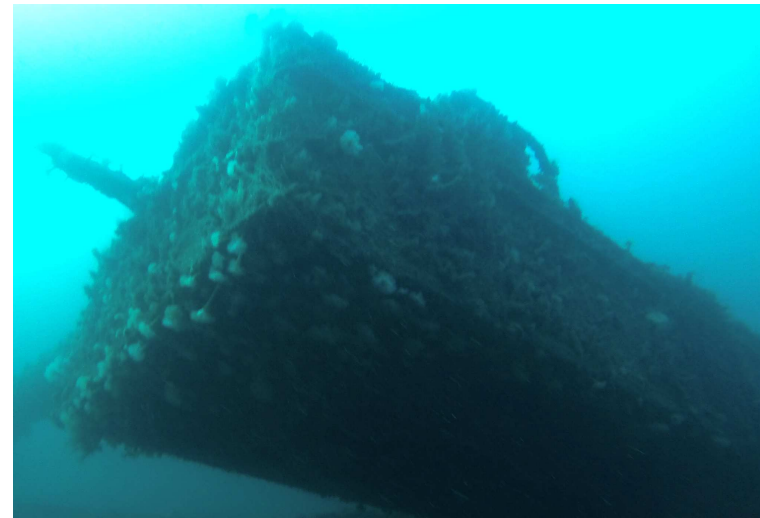
C: End of RC1 showing rubber joining mechanism

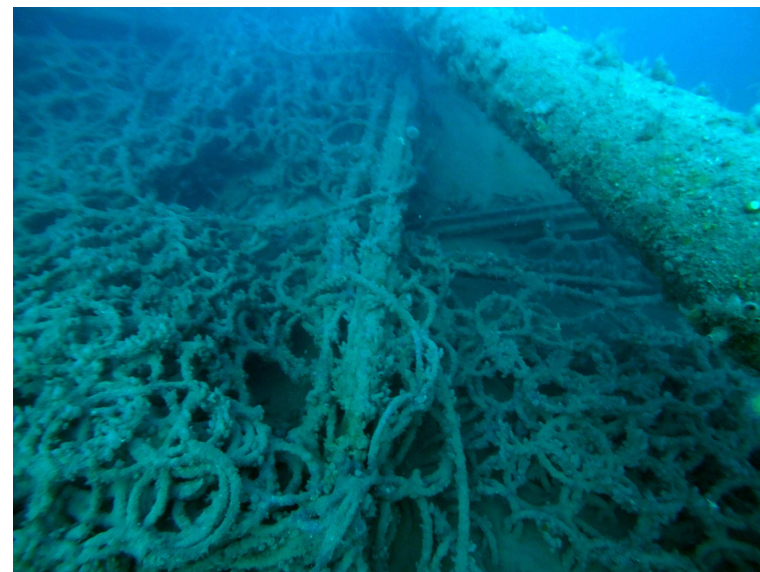
D: Netting attached to steel beams with spar B in the background

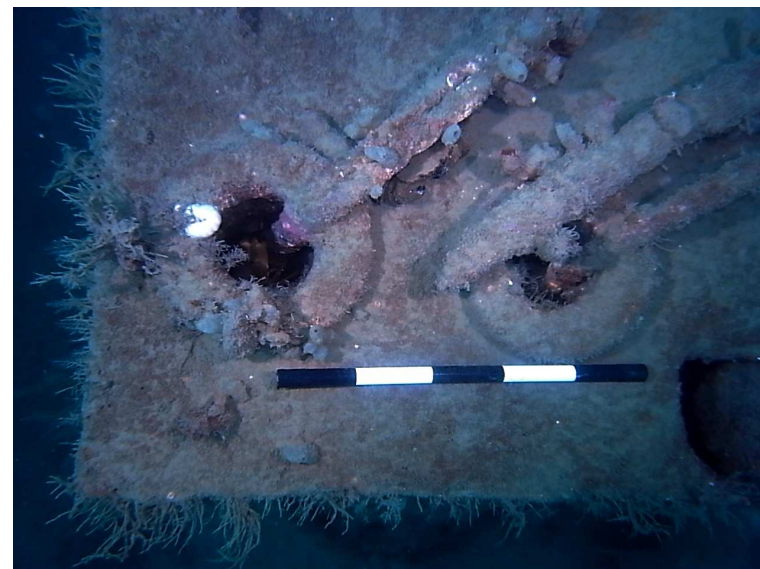
E: Apertures and wire on underside of RC2. Wires join steel beams like those shown in D

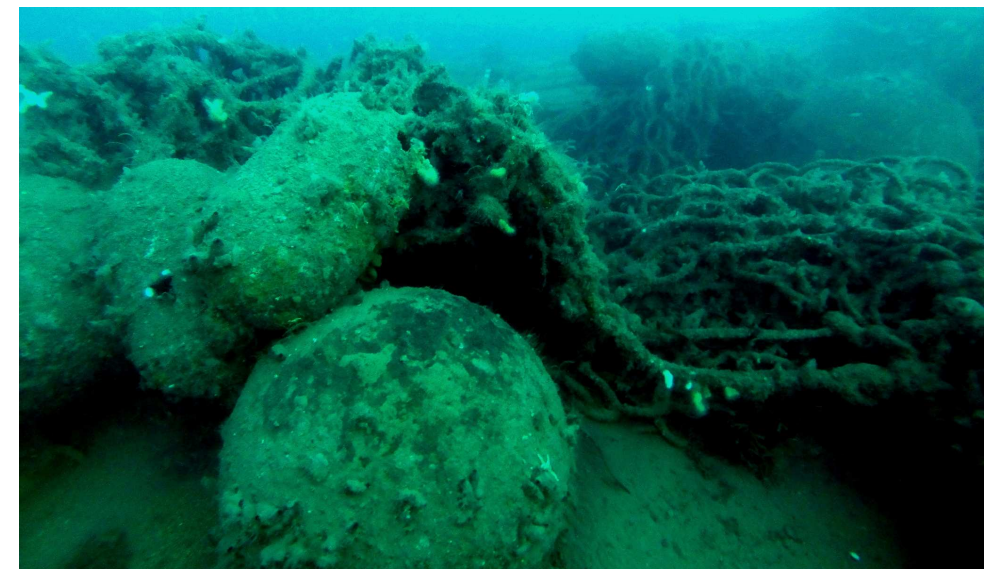
In the northwest corner of the site, a large pile of circular and ovular boom buoys and associated nets was observed. The buoys showed evidence of corrosion around distinct circular holes but were otherwise intact (**Plate 8**). The circular holes are likely to have been caused by small artillery shells used to sink the buoys. It is probable that these buoys were sunk after RC1 as they overlay the wreckage around the middle section.

F: Boom buoys and net on northwest side of RC1, with RC1 visible in the background

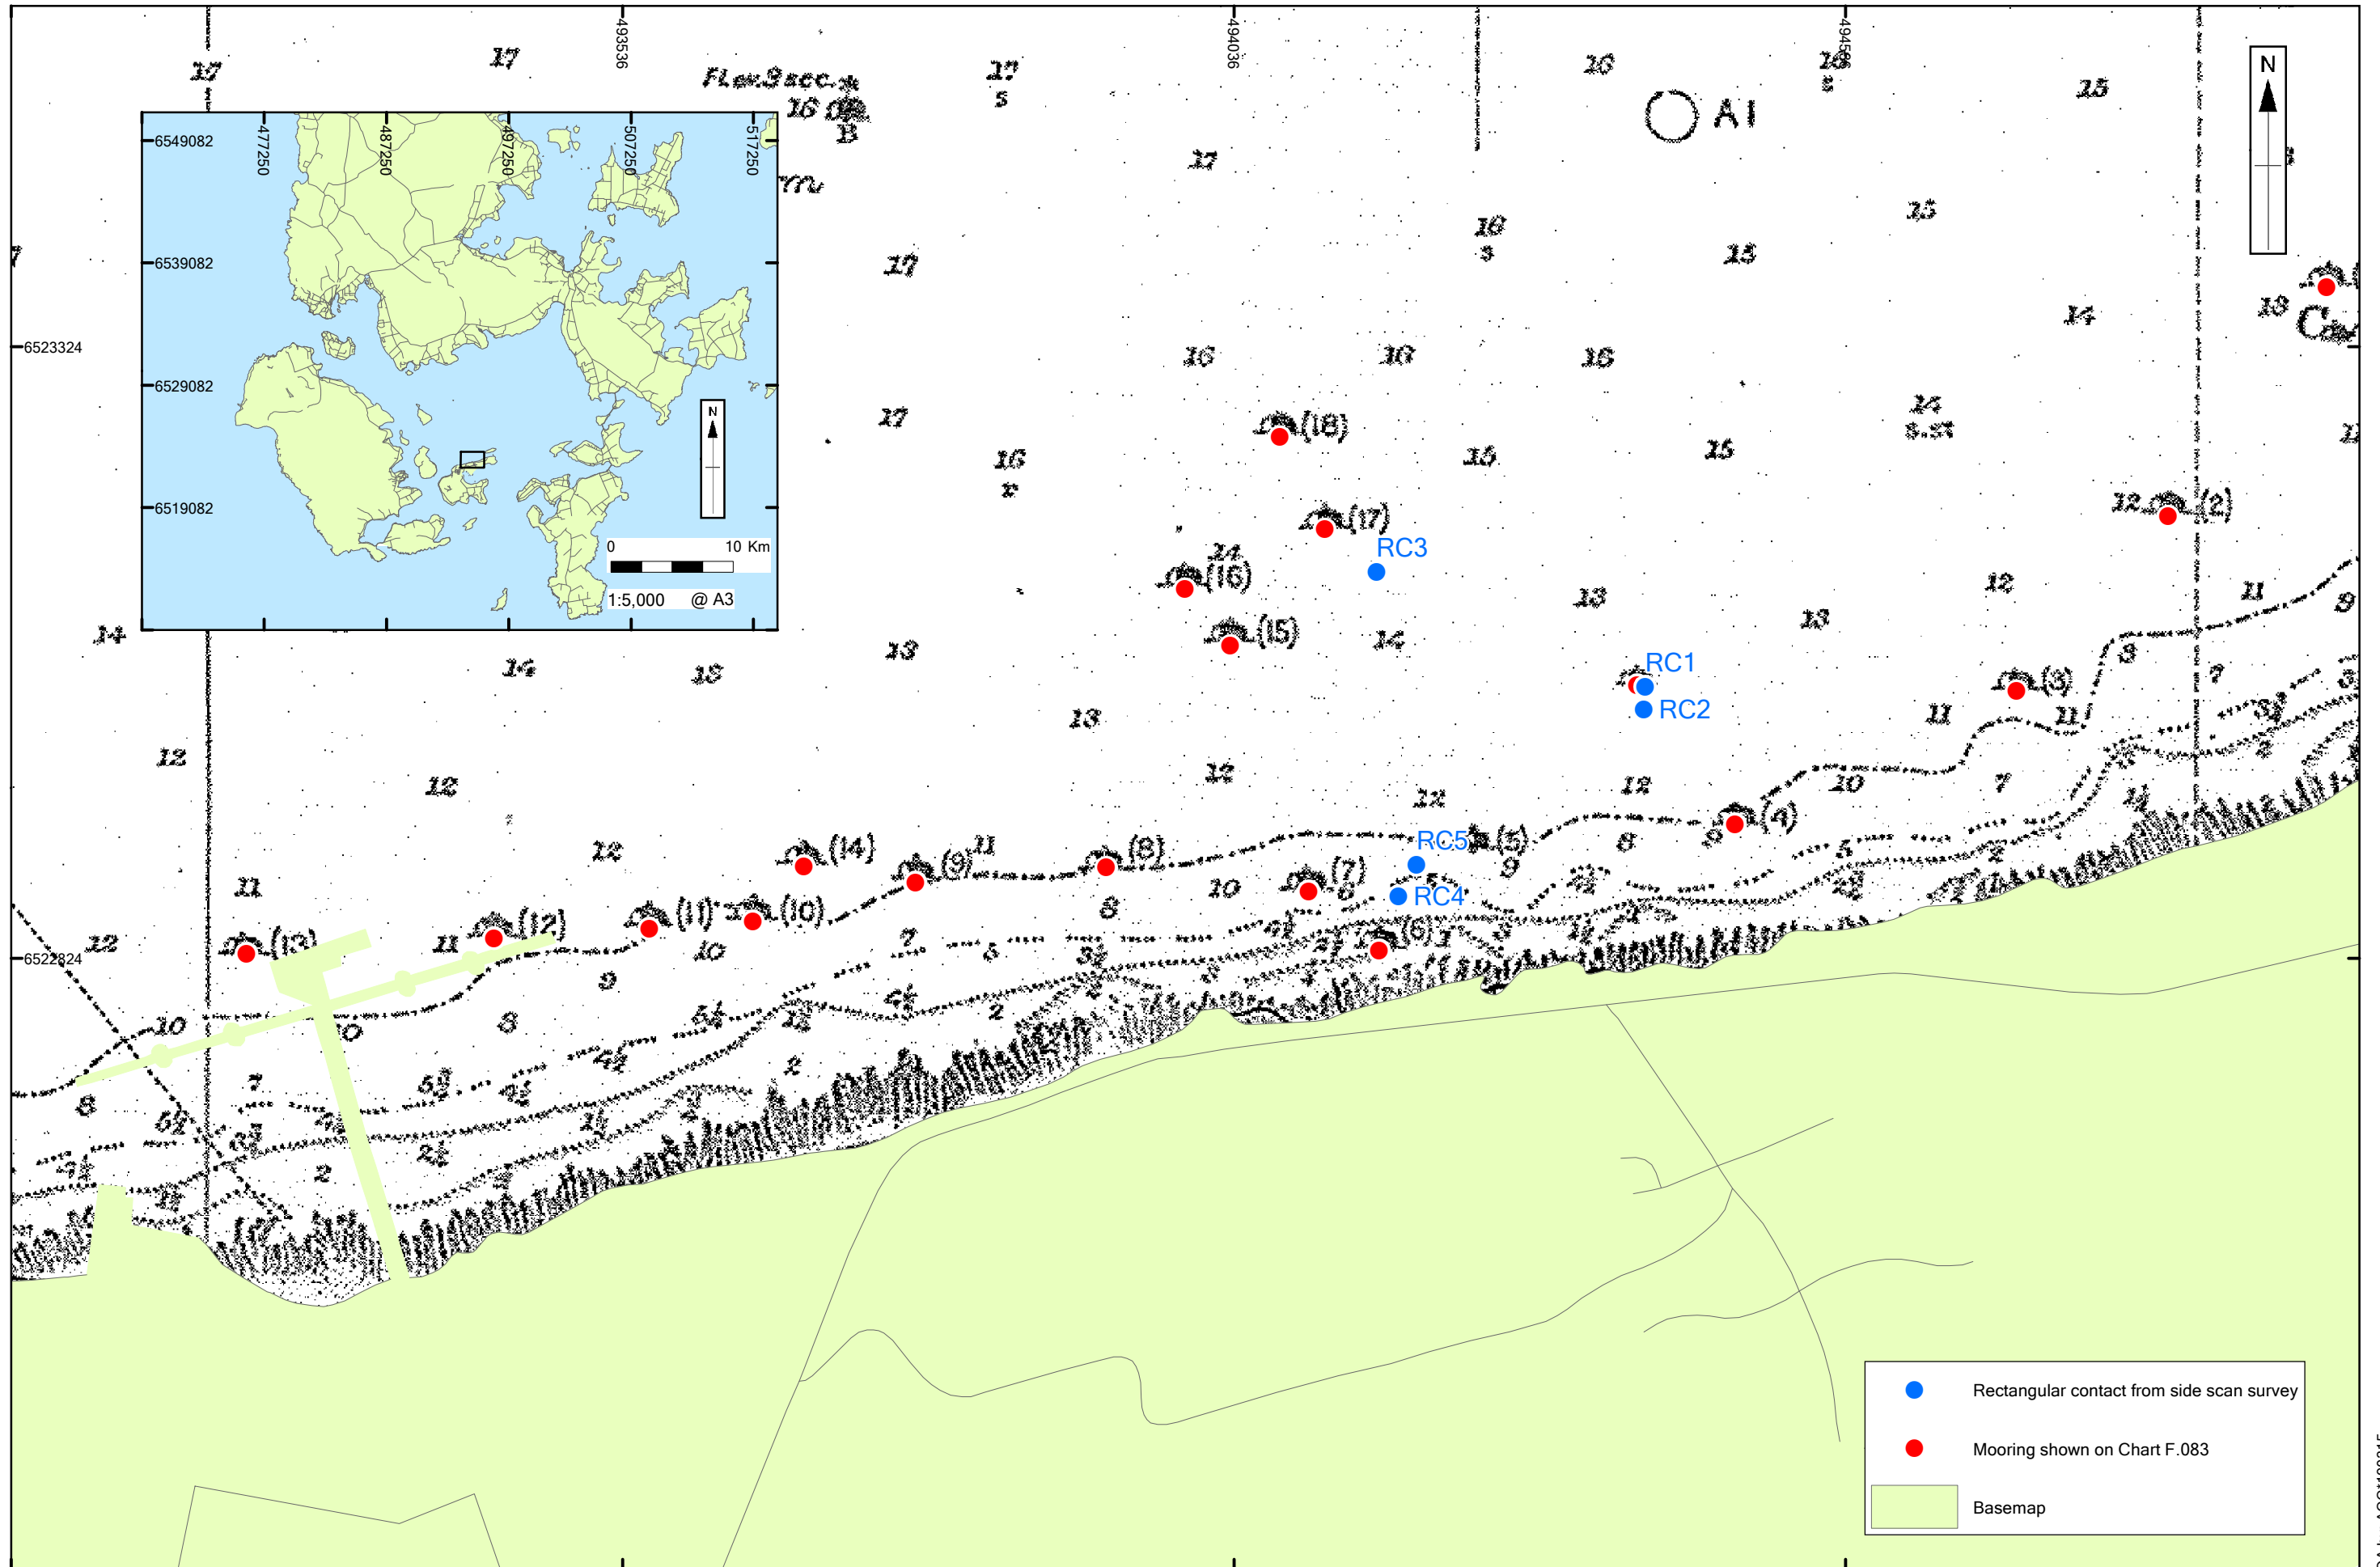
Figure 3: Distribution of rectangular contacts in  
relation to moorings detailed on historic chart

The depth of netting beneath the vessel also restricted the docking of the pontoons alongside harbour facilities, suggesting that they would have been stored on nearshore moorings. Historic charts of the area to the north of Flotta show the positions of eighteen mooring buoys close to shore but in sufficient water depth to facilitate the storage of these vessels with their associated netting. Post processing of the side scan sonar data show that the target site (RC1 and RC2) and the second pair of rectangular contacts (RC4 and RC5) are situated close to specific moorings indicated on the historic chart. This could support the interpretation that these moorings were used to store the pontoons when not deployed (**Figure 3**).
